2015 PUBLIC STORMWATER DETENTION BASIN STUDY

FINAL REPORT

January 25, 2016

CITY OF ANKENY
2015 PUBLIC STORMWATER DETENTION BASIN STUDY

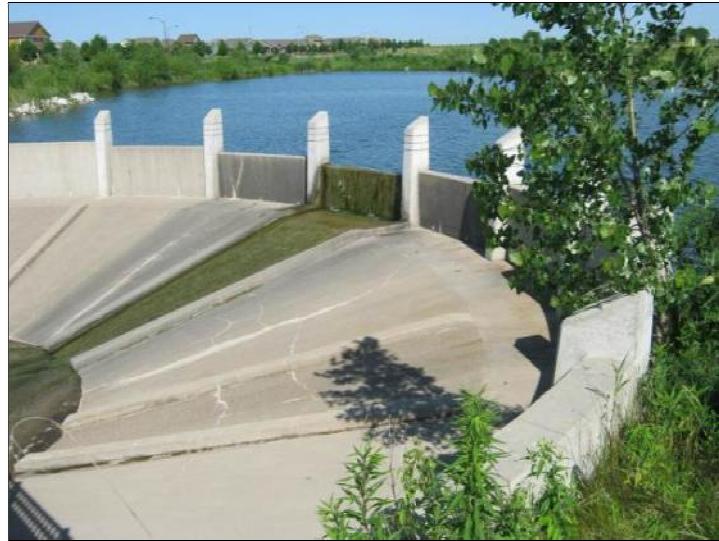
During HR Green's initial field review, cracked concrete was observed in the outlet structure of Vintage Park Basin. A structural engineer from HR Green conducted a follow-up inspection of the structure and a review of recorded engineering drawings to evaluate these cracks. It was determined that these cracks do not pose a serious threat to the integrity of the structure or to public safety.

The consulting team recommends the City consider fencing the outlet structures at both the Vintage Park and Promenade Park Basins to prohibit unauthorized entry to the weir edges of the structures. Currently, the structures are easily accessible from the adjacent grounds. A fall into these structures would likely result in serious injury or fatality, especially in periods when significant water flow is passing over the weir (see photo).

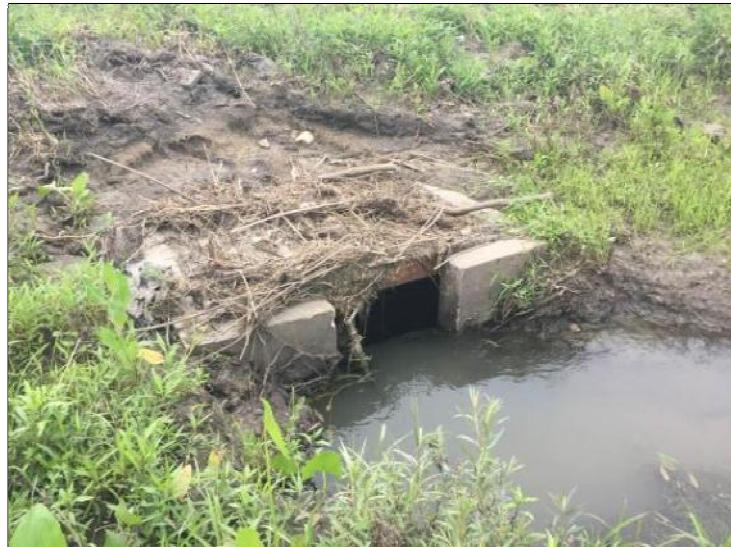
3.6.1 Tradition Basins Outlet Structures

The outlet structures at both Tradition Basins (North and South) have an unsafe design feature. These structures have unscreened openings of approximately 27 inches, and are easily accessible via shallow wading. Water entering the structure plunges vertically into a turbulent vortex. Additionally, the grating on both structures has crudely cut openings with sharp edges (see photos).

These outlets should be replaced with a safer design, such as a SUDAS standard SW-series structure. This report also recommends a more detailed analysis and redesign of the Tradition Basins because they do not appear to currently meet the intended engineering functionality, as evidenced by local erosion, sedimentation, and the large drainage area compared with the

size of the basins. That analysis may recommend substantial reconstruction of the Tradition Basins system. The City may wish to post warning signs at these structures for public safety while that analysis and redesign is underway.

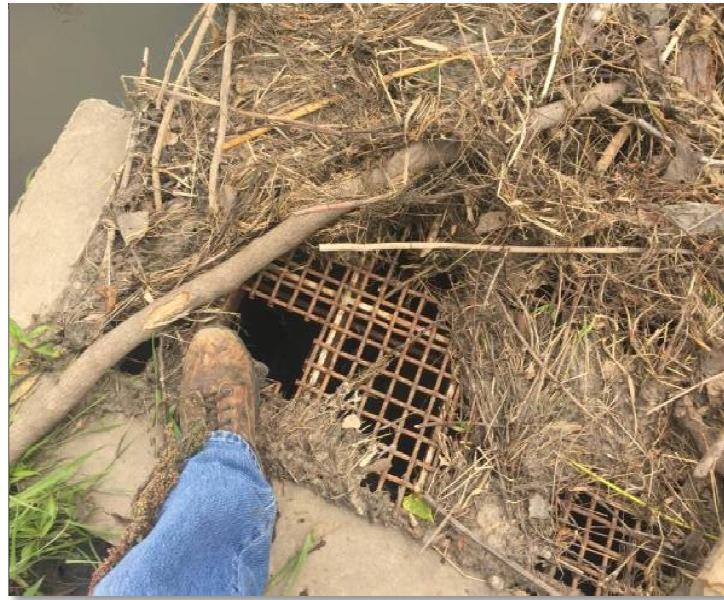
3.6.2 Minor Safety Issues

The following minor safety issues were noted at various basins throughout the City. None of these issues is likely to cause serious injury or fatality. If the City wishes to address these issues, many could be rectified by simple maintenance projects.

1. *NE-01, Otter Creek Basin.* There is a protruding rebar on the 36" RCP inlet, which may represent a tripping/minor injury hazard.
2. *NE-03, Deer Creek Basin.* Along the adjacent NE Frisk Drive, there is an eroded intake on an 8" PVC inlet with no cover. This may cause a minor tripping/injury hazard, and also makes the inlet prone to clogging.

3. *NW-05, Georgetown South Basin.* There is a protruding rebar on the 30" RCP inlet, which may represent a tripping/minor injury hazard.
4. *NW-08 & 09. Prairie Ridge Complex North and South Basins.* There are numerous areas of steep banks around both basins, especially on the southern shorelines. These may cause a tripping hazard, but the water adjacent to them is quite shallow. Therefore, tripping in these areas would not represent a significant drowning risk.

5. *NW-13, Cherry Glen North Basin.* Sub-standard-size rip rap at the inlet may roll underfoot, causing risk of minor injury.
6. *NW-16, Signature Basin.* There is a near-vertical drop along the entire length of the southern shoreline, caused by wave erosion. The adjacent water is quite shallow, minimizing drowning risk, but the severely eroded shoreline does pose a tripping hazard. Stabilization of this eroding shoreline is discussed later in this report.

7. *SW-06, Hy-Vee South Basin.* The slopes of this basin are quite steep, and mowing is likely hazardous. This may pose a rollover/injury hazard. The re-grading of these slopes is not likely feasible, since all surrounding areas are now developed and paved. The consulting team understands these slopes were seeded with native grasses. It is recommended that deck-mowing be avoided on these slopes, and that backpack weed trimmers or similar equipment be used if necessary during native vegetation establishment, and that prescribed burning be used for long-term management.

8. *SW-10, Vintage Park Basin and SW-07, Promenade Park Basin.* Each of these parks has a large concrete outlet flume (discussed in Section 2.2). These structures can be easily accessed on foot. It is recommended that the City consider fencing to prohibit unauthorized entry to the weir edges.
9. *SW-11, Art Center Basin.* Much of the riprap surrounding this basin was quite unstable under foot, resulting in a moderate tripping hazard. Some of the riprap has either slid into the basin or been incorporated into the surrounding slopes. Art Center Basin is one of the older basins in the City.

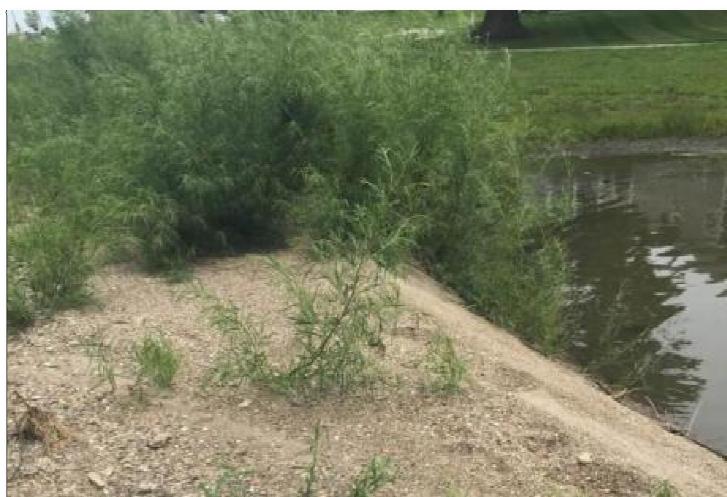
The Tradition Basins are significantly undersized for their watershed area, and are not providing adequate detention of stormwater runoff. Saylor Creek flows directly through both basins. The Basin Classification and Criteria Matrix (Appendix B) shows that the watershed to basin ratio for these basins is approximately 2000:1. This ratio is many times higher than the ratios at other basins throughout the Ankeny stormwater management system, and well beyond widely accepted engineering guidelines. The recommended watershed-to-basin ratio is highly dependent on watershed characteristics, but values ranging from 10:1 to 75:1 are advisable in Iowa. The higher end of this acceptable range is recommended only for watersheds with a significant proportion of permanently vegetated surface, such as prairie or woodland. While there are other stormwater basins and water control features upstream to help manage watershed flows, the Saylor Creek watershed is a large watershed that experiences considerable flow volumes and rates. During our field assessment, the area just upstream of the Tradition Basins was observed to be under repair, apparently due to recent erosive stormwater flows and alignment of a box culvert. Past rainfall events have also caused visible degradation of both basins, as described below.

- A large sand-and-gravel delta has formed at the inlet to Tradition North Basin. In time, this basin will be completely filled with sediment (see photo).

The consulting team recommends that the City conduct a detailed drainage analysis, if one does not exist, to determine the proper sizing for the Tradition Basins system. The analysis should examine the feasibility of upstream volume and rate control measures in conjunction with improving the basins to provide adequate detention. The analysis should also evaluate the effects of taking the Tradition Basins system off-line from the flow-through stream, so that they would provide stormwater detention for only the adjacent development area. Such a project would need to be constructed in conjunction with a stream channel rerouting and stabilization project for Saylor Creek.

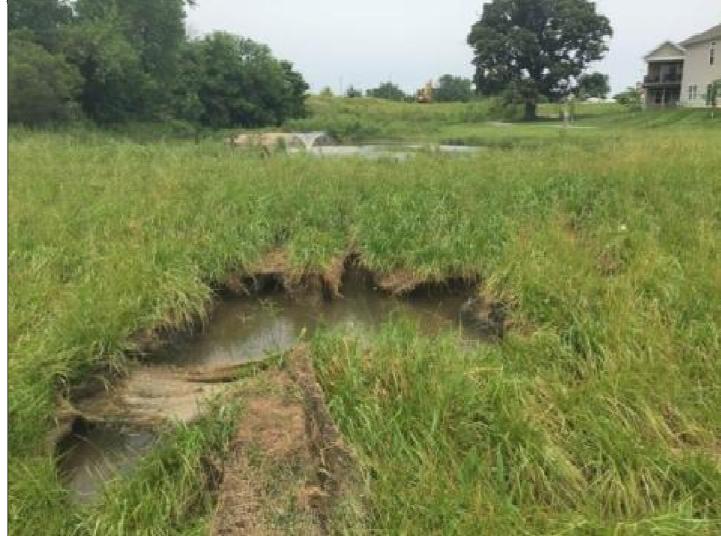
- Significant erosion was observed in soils downstream of both basins, indicating regular passage of large flows over the outlet structures (see photo).
- Significant sedimentation was observed in Tradition South Basin, leaving very little deep water habitat (no photo).

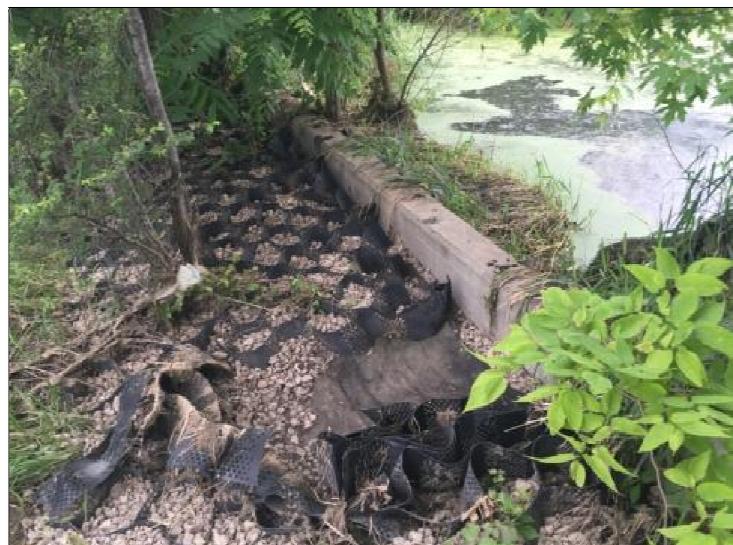
This basin is a remnant farm pond that existed prior to development of the area. HR Green's review of historical aerial photography revealed that the basin has existed since at least the 1950s. Development of the adjacent area occurred primarily between 2002 and 2006. There are signs that the Wildflower Basin may not provide adequate stormwater detention. Depressed grass observed in the emergency outlet area indicated that the basin had recently overflowed the emergency outlet weir. Additionally, the fabric matrix reinforcement of the outlet weir area is beginning to erode visibly (see photo). Residents indicated that the basin has been prone to flooding in the past. Based on HR Green's

onsite depth readings, the basin appears to have a maximum depth of approximately 3 feet at normal pool. Extensive siltation of the pond appears to have occurred in the 60 plus years since it was constructed.

HR Green reviewed drainage calculations for the Wildflower Basin performed by other consultants during the development of adjacent areas. One item of concern is that the Rational Method was used in those earlier calculations. The Rational Method is not recommended for drainage areas larger than 40 acres, as it tends to underestimate flows for larger areas. The total watershed area draining to the Wildflower Basin is approximately 63 acres. Although the basin was designed to overflow the outlet weir with the 100-year storm, overflows appear to be occurring much more frequently.

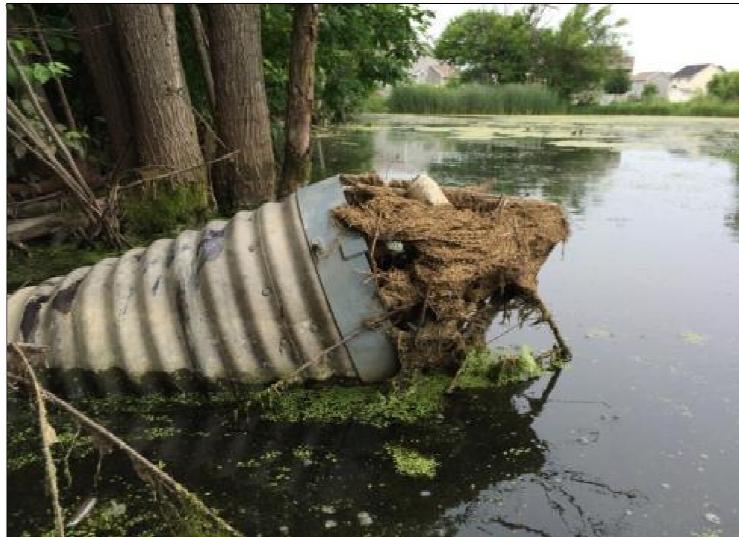
These periodic overflows, however, may be related to the basin's aging and obsolete outlet structure. The outlet consists of a corrugated metal pipe with a conical trash basket (see photo). This type of outlet is prone to clogging and up-lift. Consequently, the outlet may be allowing water levels to rise higher than intended. It is recommended that this outlet structure be replaced with a standard SUDAS-type intake structure.

If replacement of the outlet structure does not remedy high water levels, then it is recommended the City conduct a detailed drainage analysis using more applicable methods in order to evaluate the Wildflower Basin capacity. Because of its long existence prior to development, this basin would likely be considered a jurisdictional wetland by the U.S. Army Corps of Engineers. Thus, any modification or dredging of the basin would require a Section 404 permit. This may create a significant regulatory challenge for any attempt to convert the Wildflower Basin into a deep-water basin. However, other types of beneficial modification could be conducted without the need for mitigation.

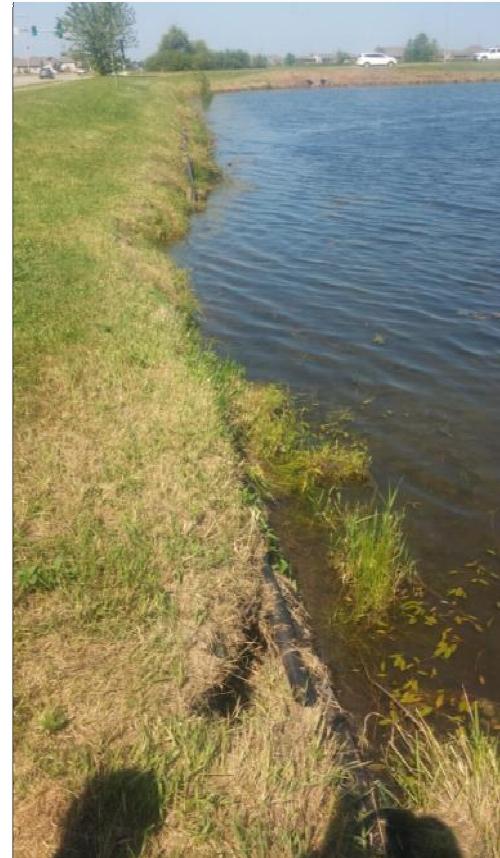
Signature Basin Shoreline Stabilization

The eroded south shoreline of Signature Basin warrants stabilization (see photo). Due to the proximity of a sidewalk and possibly buried utilities, there may be constraints to major re-grading of this slope to a stable angle of repose. However, using a combination of stabilization treatments, such as coir logs, erosion blankets, and native plantings, will provide a long-term solution to this erosion issue.

shoreline (approximately 380 feet), we recommend a budget of \$30,000 to stabilize this section of shoreline.
