# AMERICANS WITH DISABILITIES ACT TRANSITION PLAN

CITY OF ANKENY, IOWA  
AMERICANS WITH DISABILITIES ACT - TRANSITION PLAN

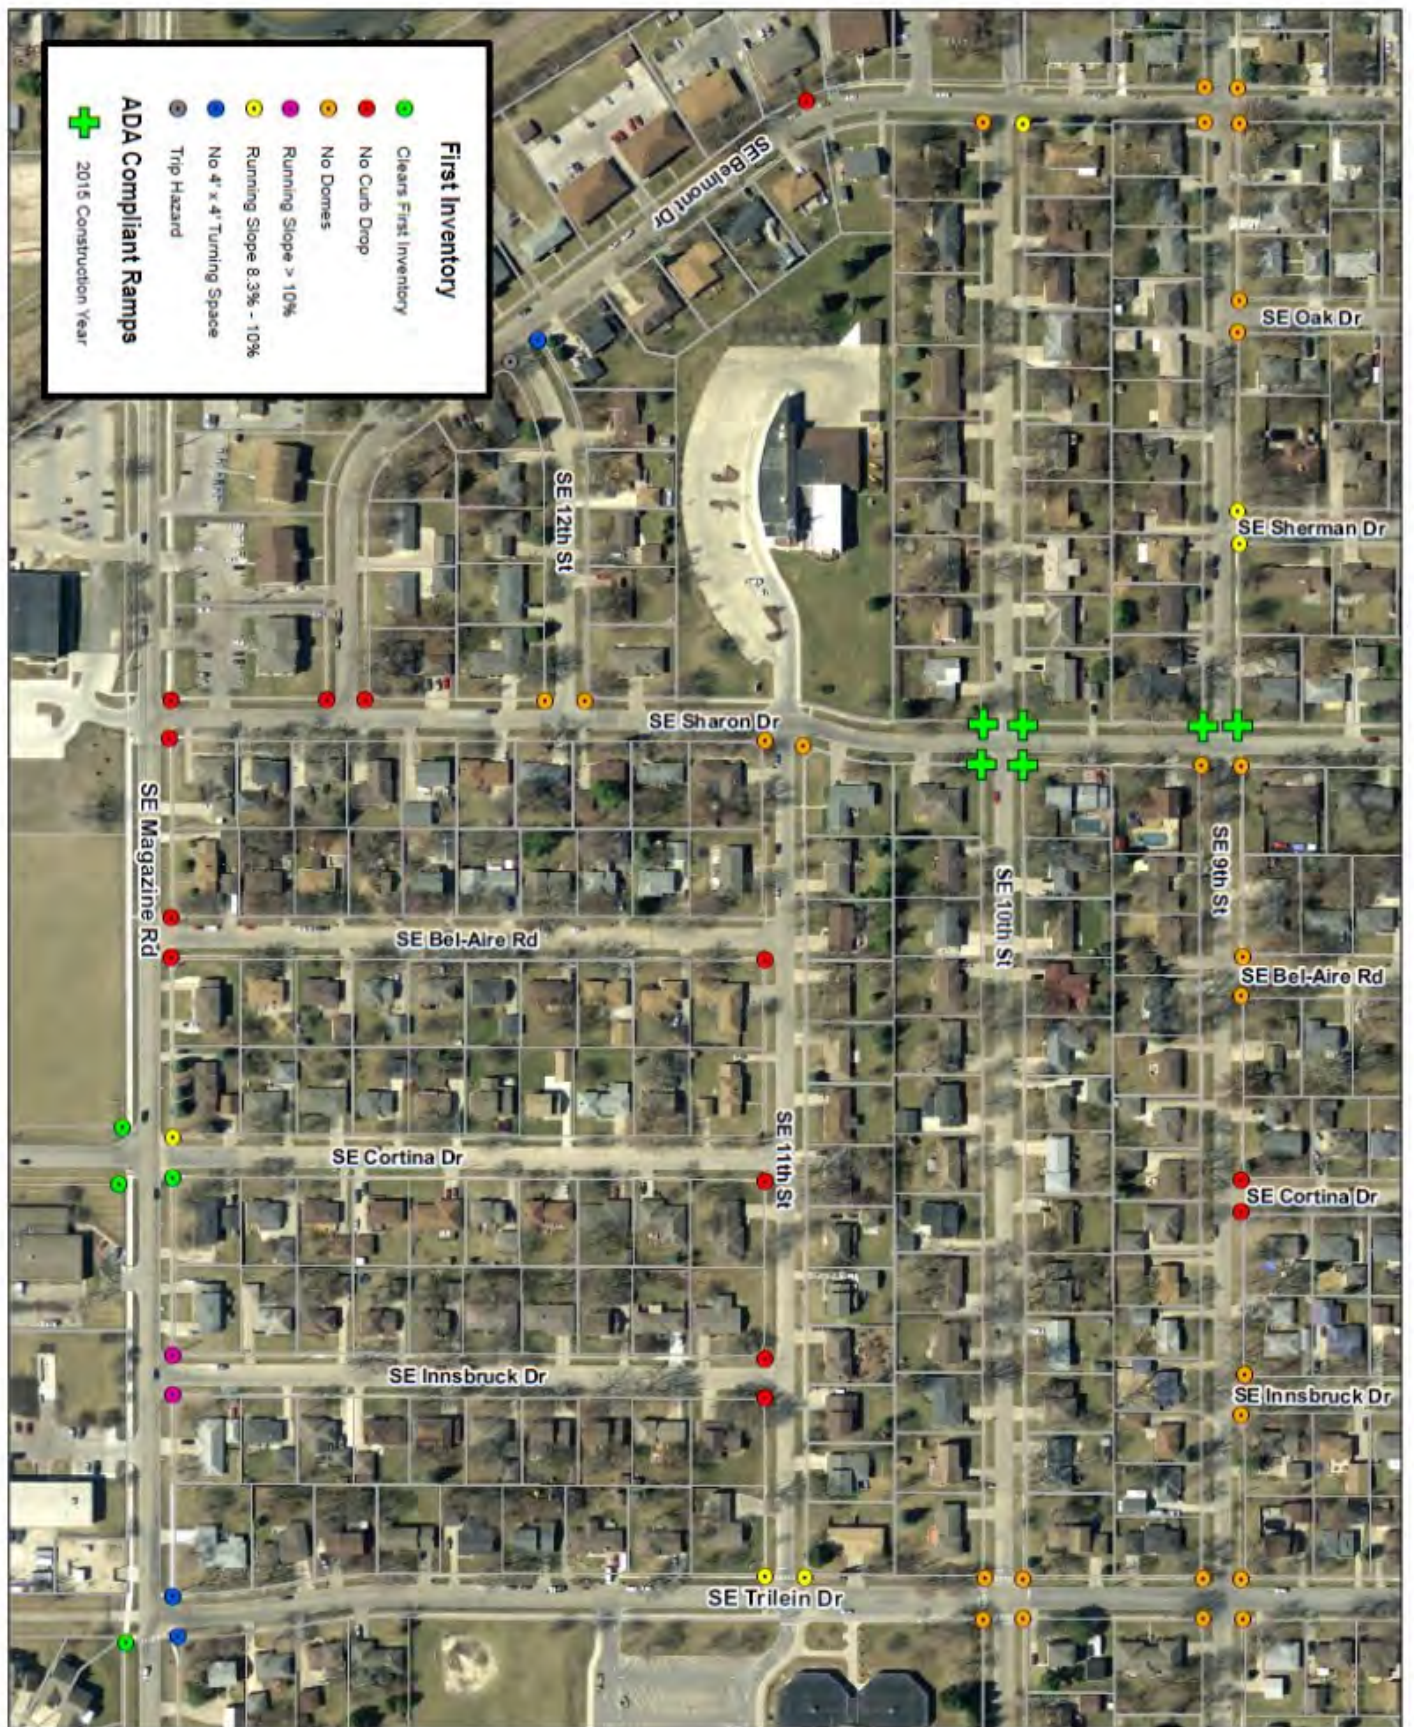
Page 13 shows a small section of the southeast quadrant of Ankeny with the results of the public works survey shown by color coding. This aerial is an excerpt from Ankeny's GIS system, which includes the data for all ramps that were surveyed. The key for this map shows the specific defects that were identified, or if the ramp meets the current requirements / standards (Clears First Inventory).

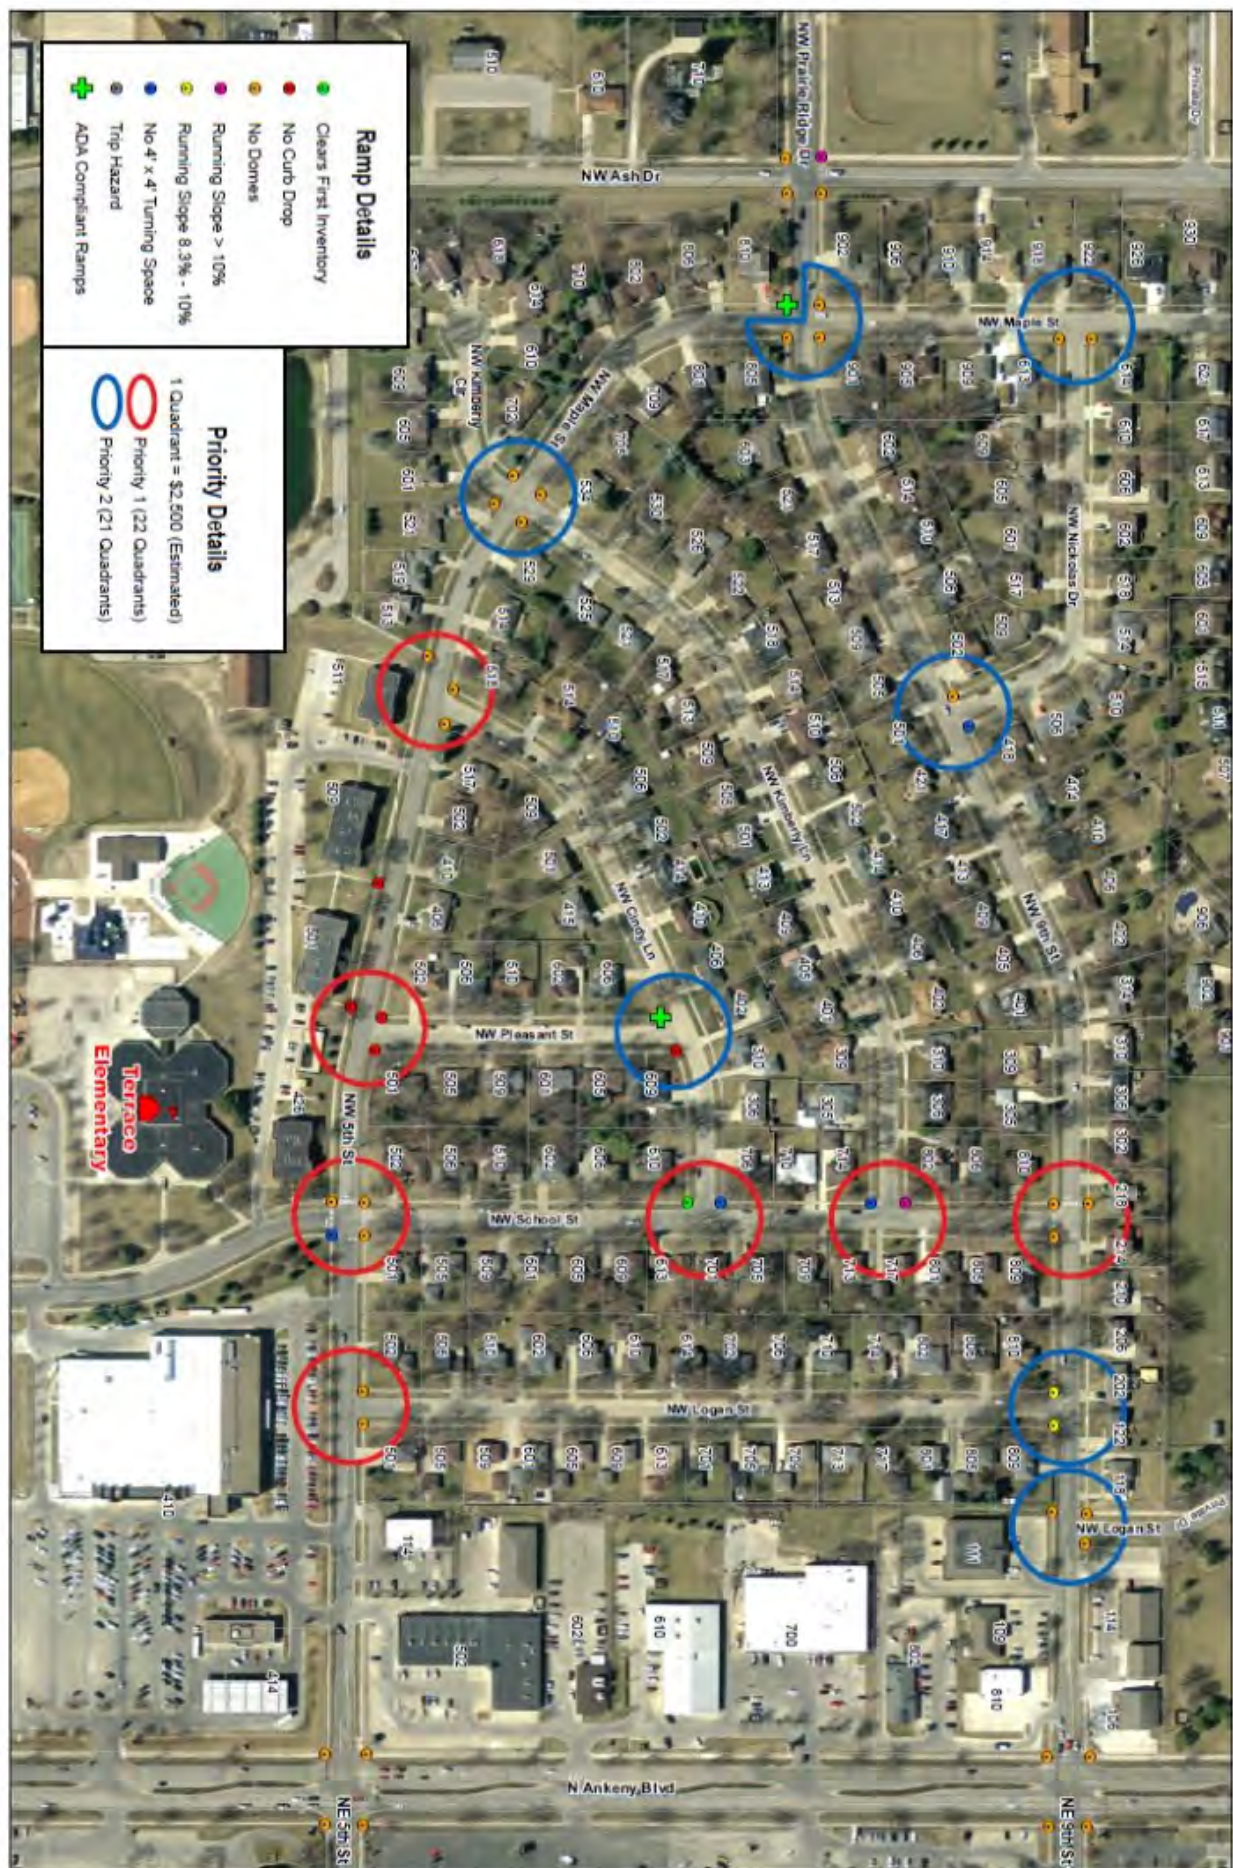
Page 14 is an aerial view of the defective ramps in the Parkview Terrace neighborhood. The specific defects are noted by color-coding.

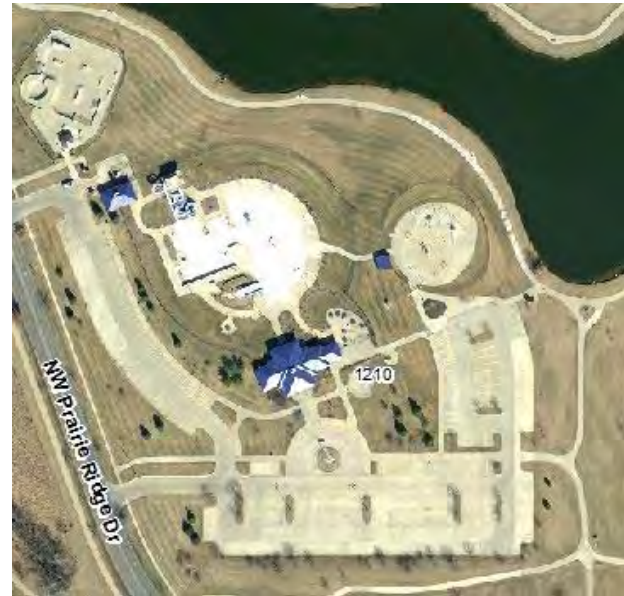
**Inventory:** This large parking lot is comprised of three different but connected bays of stalls that serve three separate civic facilities: the Ankeny Skate Park, the Prairie Ridge Aquatic Center, and the Prairie Ridge Splash Park.

A circular drop-off is included in front of the main entrance to the aquatic center. The three lots are PCC curb-and-gutter with standard stall markings. There are a total of 245 stalls available. The lots currently has 12 marked handicap ramps. Each of these is marked as required, but signs need to be installed behind some of the stalls. There are seven access points from the lots. Each of these includes drop curb ramps that appear to be of the correct dimensions to meet ADA compliance. However, these ramps have not been surveyed and measured by Ankeny Public Works.

**Priority 1 Actions:** The missing handicap signs need to be installed behind each of the handicap stalls as required. This is scheduled to be completed in the summer/fall of 2016.

**Priority 3 Actions:** Any of the 7 drop curb ramps that are found to be out of compliance will need to be repaired / replaced.

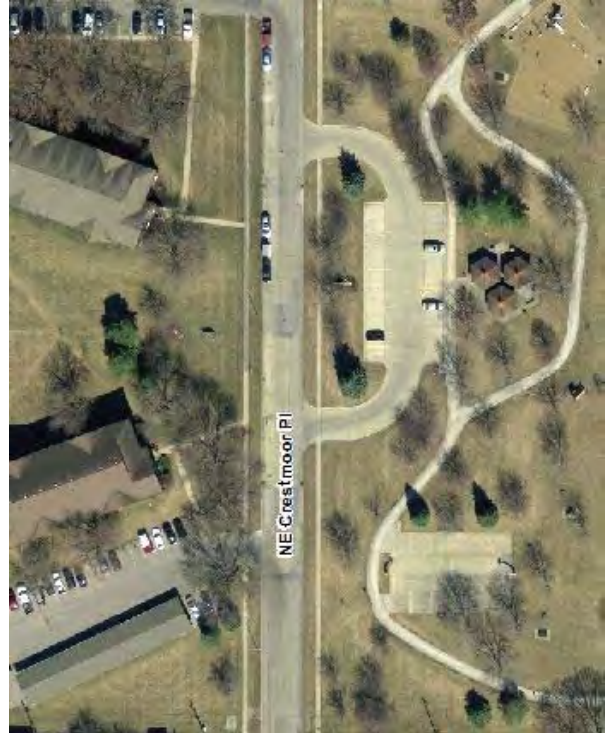
### 3. Crestbruck Park Parking Lot NE Crestmoor Place at NE 9<sup>th</sup> Street

**Inventory:** This small lot is located on the west side of Crestbruck Park. It contains 23 parking stalls. The lot is in fair condition. The lot forms a “circle” drive off of NE Crestmoor Place. There is one handicap stall for the lot, which meets the requirements for location and quantity. However, this stall does not appear to be large enough to function as a van-accessible handicap stall.

There is one access point for the lot, where pedestrians exit the parking lot and enter onto the 8’ recreation trail. This is located in the center of the east row of parking stalls. From this point, pedestrians can utilize the adjacent shelter and playground, or use the trail to reach the other facilities in the large park. This access has a drop curb but does not have tactile panels.

**Priority 1 Actions:** Remove the existing symbol from the handicap stall and repaint with the current standard symbol. Repaint the handicap stall so that it is of the correct dimensions for a van-accessible stall. Also install a van-accessible handicap sign behind the stall.

**Priority 2 Actions:** Public works needs to measure the access dimensions and grades to insure compliance.

**Priority 3 Actions:** If public works finds that the access is out of compliance, it will need to be repaired / replaced.

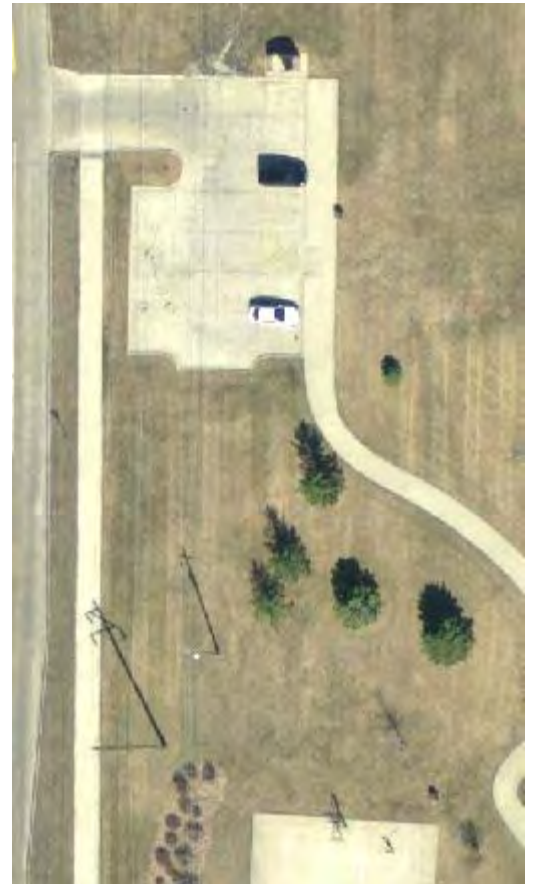
**5. Glenbrook Park Parking Lot**  
**2803 SW Glenbrook Drive**

**Inventory:** This small parking lot contains 13 parking stalls, one of which is a handicap stall located in the northeast corner of the lot. A dropped-curb access is located next to the handicap stall. The layout includes a van-accessible access aisle adjacent to the handicap stall as required.

**Priority 2 Actions:** Public works needs to measure the drop-curb access ramp dimensions and grades to insure compliance.

**Priority 3 Actions:** If public works finds that the access is out of compliance, it will need to be scheduled for repair / replacement.

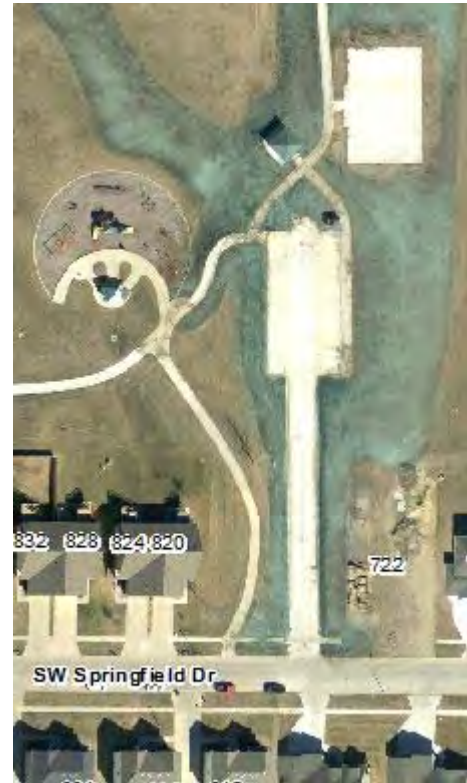
### 13. Sawgrass Park Parking Lot SW Sawgrass Parkway

**Inventory:** The lot is located within a park in the southwest section of Ankeny. The lot is PCC with curbs, and has 20 parking stalls. One handicap stall is provided, and it is van-accessible. This meets the requirements. However, handicap signs are not provided behind the stall. There is an adjacent drop-curb access ramp that connects the lot to the playground, fishing dock and the trail system within the park. This ramp has the required truncated dome panels.

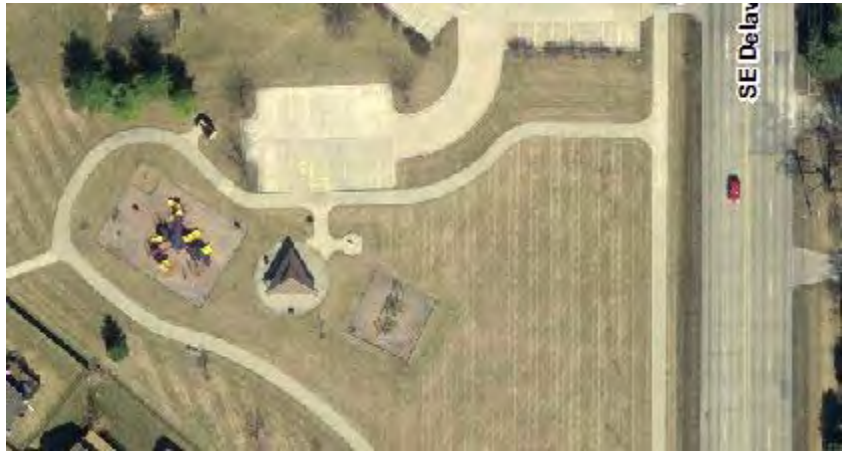
**14. Summerbrook North Park Parking Lot  
SE Delaware Avenue and SE 8<sup>th</sup> Street**

**Inventory:** This small lot is located within a park in the southeast section of Ankeny. The lot is PCC with curbs, and has 14 parking stalls. One handicap stall is provided, and it is van-accessible. However, handicap signs are not provided behind the stall. Also, the stall needs to be moved so that it is on the correct side of the provided turning space. There

is an adjacent drop-curb access ramp that connects the parking lot to the playground, shelter and the trail system to the south within the park. This ramp has the required truncated dome panels.

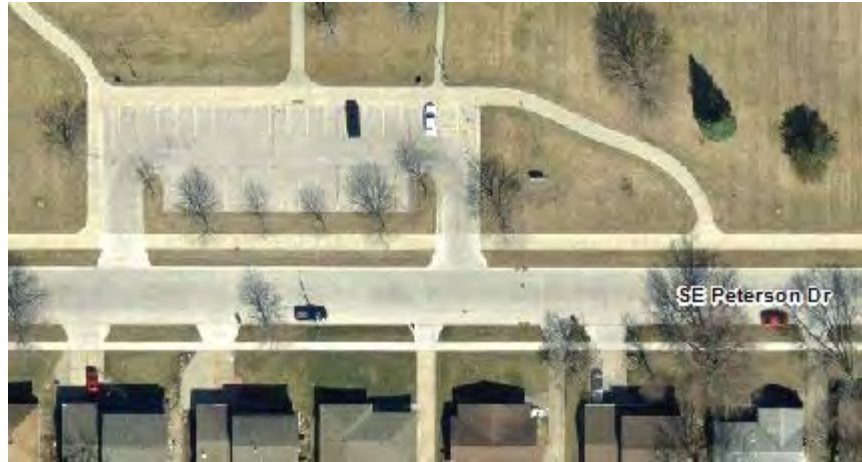
**Inventory:** This lot is located within an older, central section of Ankeny. Sunrise Park has a number of amenities and is heavily used. The lot is PCC with curbs, and has 30 parking stalls. Two handicap stalls are provided, and one is van-accessible. However, handicap signs are not provided behind the stalls. There are two drop-curb

access ramps that connect the parking lot to the shelter, ball diamond, playgrounds and the trail system that borders the park. One of these ramps has the required truncated dome panels.

**Priority 3 Actions:** The access ramp needs to be reconstructed so that the required truncated dome panels are provided.

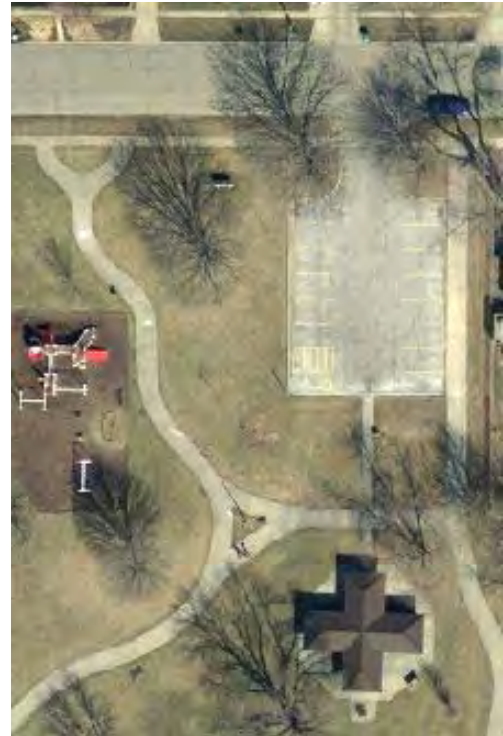
**17. Westwinds Park Parking Lot**  
**SW Irvinedale Drive and SW Woodbury Drive**

**Inventory:** This small lot is fairly new and serves one of the busiest parks within the city. The lot holds 14 cars. One handicap stall is provided, next to the access ramp located in the northwest corner of the lot. The stall is located on the wrong side of the turning space... Also, handicap signs are not provided behind the stall. There is one drop-curb access ramp that connects the parking lot to the shelter, tennis courts, and playground. The ramp has the required truncated dome panels and appears to be fairly new and constructed correctly.

**Priority 2 Actions:** None contemplated at this time.

**Priority 3 Actions:** None contemplated at this time.

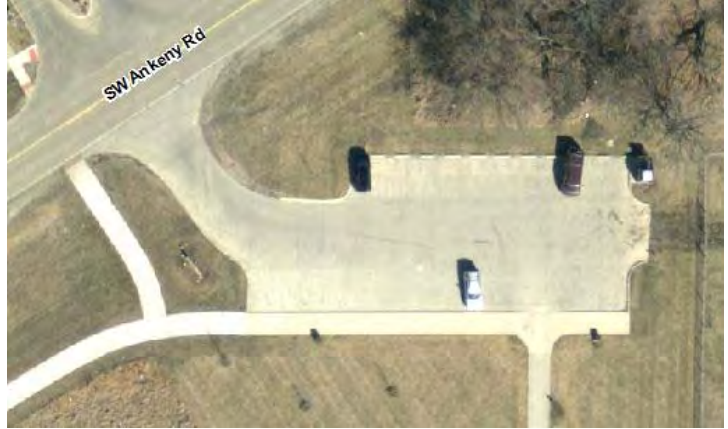
**19. Ankeny Dog Park Parking Lot**  
**SW Ankeny Road and SW Twin Gates Drive**

**Inventory:** This lot serves the popular Ankeny Dog Park. It contains 24 parking stalls. The lot is connected to a recreation trail that provides access to the fenced-in dog run area, as well as circumvents the perimeter of the park (Somersby Park). The lot contains one handicap stall that is van-accessible as required. The stall is adjacent to the drop-curb trail access point. This ramp does not have the required truncated dome panels.

**Priority 1 Actions:** For the handicap stall to meet current standards, an R7-8 handicap sign and a “van-accessible” plaque will be installed behind the stall. This work is scheduled for the summer of 2016.

**Priority 3 Actions:** The ramps that do not have the truncated dome panels or are otherwise out of compliance need to be reconstructed so that the required truncated dome panels are provided. If public works finds that the west access is out of compliance, it will need to be reconstructed as well.

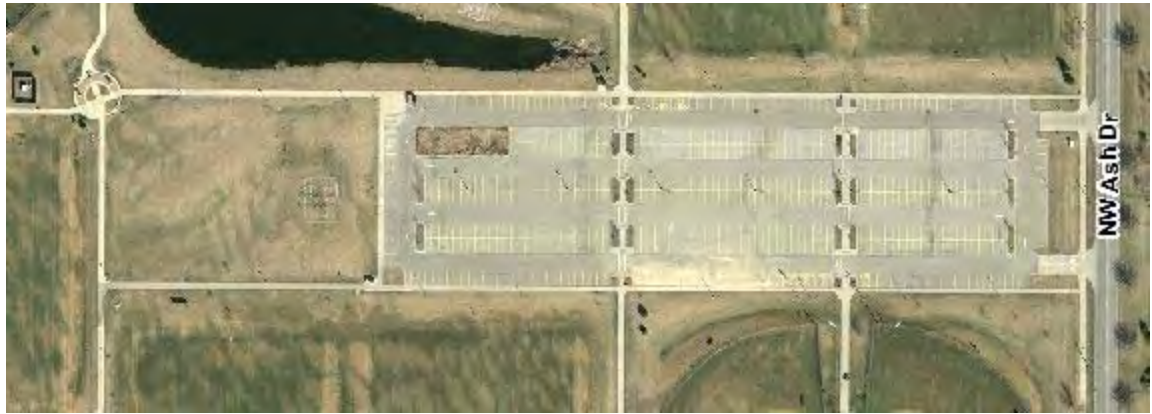
**21. Prairie Ridge Sports Complex  
NE Ash Drive Parking Lot**

**Inventory:** This lot is located within the Prairie Ridge Sports Facility. The lot is one of Ankeny's largest, as it contains 603 parking stalls. Of these stalls, 2 are van-accessible handicap stalls and 12 are regular handicap stalls. This meets the ADA requirements, which calls for 2 van-accessible stalls and 11 handicap stalls. 7 of these stalls are adjacent to the north trail connection, and the other 7 are adjacent to the southeast trail connection that leads to the quad building and ball diamonds located south of the parking lot. The sports complex has many league-quality baseball and softball diamonds, as well as a number of soccer and football fields. There are 6 ball diamonds and 9 soccer/football fields near this lot. Of the 14 handicap stalls, 7 of them do not have the required R7-8 handicap sign nearby. The two van-accessible stalls are of the correct dimensions and are located adjacent to the drop-curb access ramps as needed. There are 6 access ramps connected to this lot. Not all of these ramps have the required truncated dome panels.

**Priority 1 Actions:** For the 7 handicap stalls, R7-8 handicap signs will be installed. This work is scheduled for the summer of 2016.

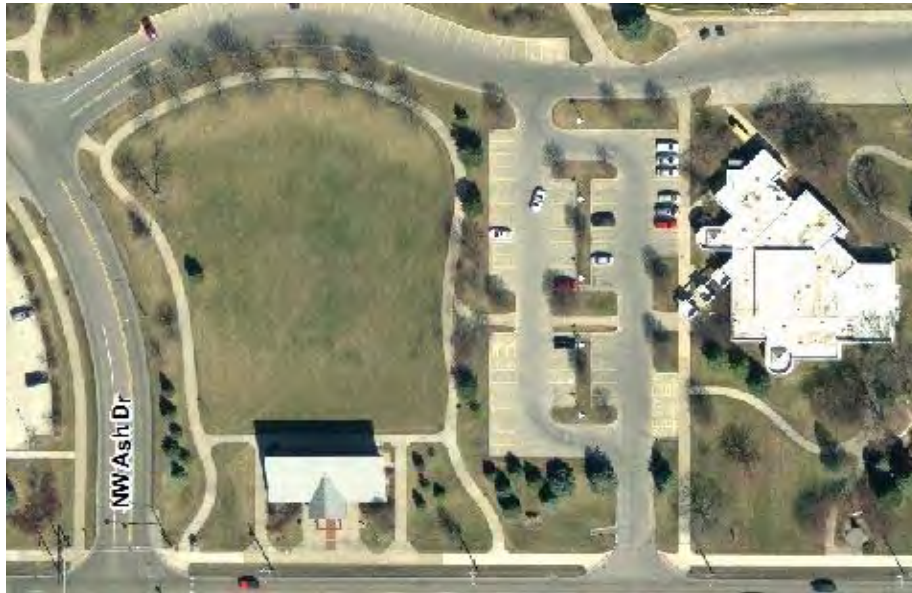
**City Hall / Wagner Park  
410 West First Street**

**Inventory:** There is one municipal parking lot that serves two city facilities: City Hall on the east and Wagner Park on the west. Wagner Park is a small open-space park that contains the Ankeny Band Shell.

The east side of this lot provides access to City Hall via two drop-curb access ramps, one directly in line with the front entrance to the building, and one located to the south of the entrance. Neither of these ramps have truncated dome panels. Adjacent to the south access is 4 handicap stalls, where only two are required. Each of these has a “van-accessible” sign behind it, but only 2 of them is adjacent to the required 96” wide turning space to qualify as van-accessible. Access to City Hall from the parking lot is via a standard sidewalk. The front doors to the building have electric push-button door openers and handicap signing. These openers are in good working order.

**Priority 1 Actions:** On the 4 handicap stalls that serve City Hall (east side), the south 2 stalls are not van-accessible. The R7-8 handicap signs should be removed and replaced with signs that do not contain the “van-accessible” designation. This work is scheduled for the summer of 2016.

**Priority 2 Actions:** Public works needs to measure the dimensions and grades of the 2 drop-curb access ramps within the parking lot to insure compliance.

**Priority 3 Actions:** The ramps do not have truncated dome panels and are out of compliance. These will need to be reconstructed to include the panels, and to also bring the ramps within compliance in regard to grades and dimensions if also needed.

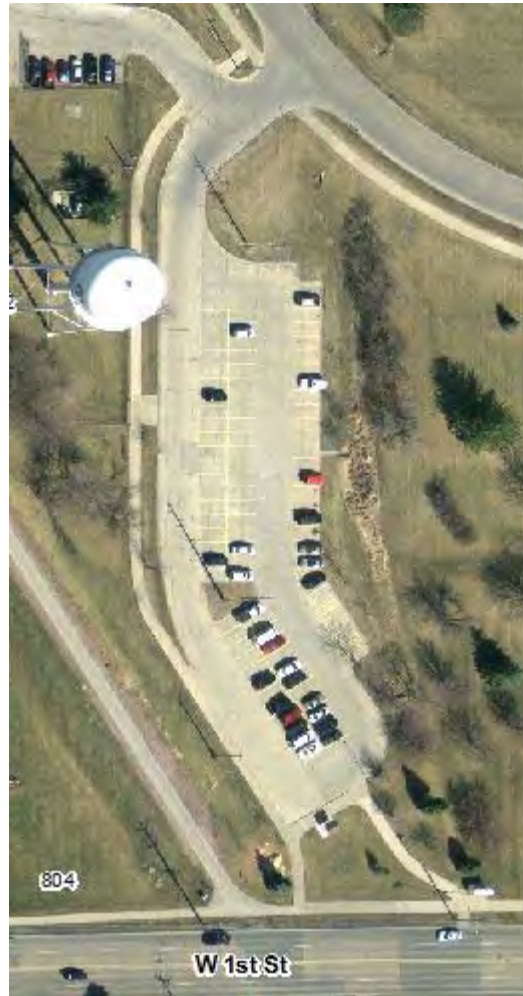
**Kirkendall Public Library**  
**1210 NE Prairie Ridge Drive**

**Inventory:** The Kirkendall Public Library is one of the civic buildings that is included in the Ankeny Facility Needs Study. According to the plan that was formulated and approved, a new civic building will be built at a different location, and this library will move to that facility. The Kirkendall Library will then be completely remodeled into office space for city department employees. The schedule for this relocation is planned for 2018 and 2019.

The parking lot that serves this building is deteriorated and is in poor condition. A complete reconstruction of this lot is planned with the building remodel. The lot has 4 handicap stalls that are adjacent to the front, main entrance into the library. One of these stalls is van-accessible. This is in compliance, as a minimum of 3 stalls are required. However, only 2 of the stalls have the required handicap signs, and those signs are in very poor condition.

The path from the parking lot into the building is a concrete sidewalk. A drop-curb access ramp is provided at the parking lot edge. This large, semi-circular ramp does not have truncated dome panels, and the ramp will need to be measured for compliance. The path from the access ramp into the library is a wide concrete sidewalk that meets the dimension requirements, but this walkway is deteriorated and is in poor condition.

**Priority 1 Actions:** For the 2 handicap stalls, R7-8 handicap signs need to be installed. One of these also needs to have the "van-accessible" designation. This work is scheduled for the summer of 2016.

**Priority 2 Actions:** No further action is planned at this time, pending the disposition of this building. When the uncertain status of the building changes, the drop curb sidewalk ramps will need to be measured, and reconstruction of these ramps should then be scheduled.

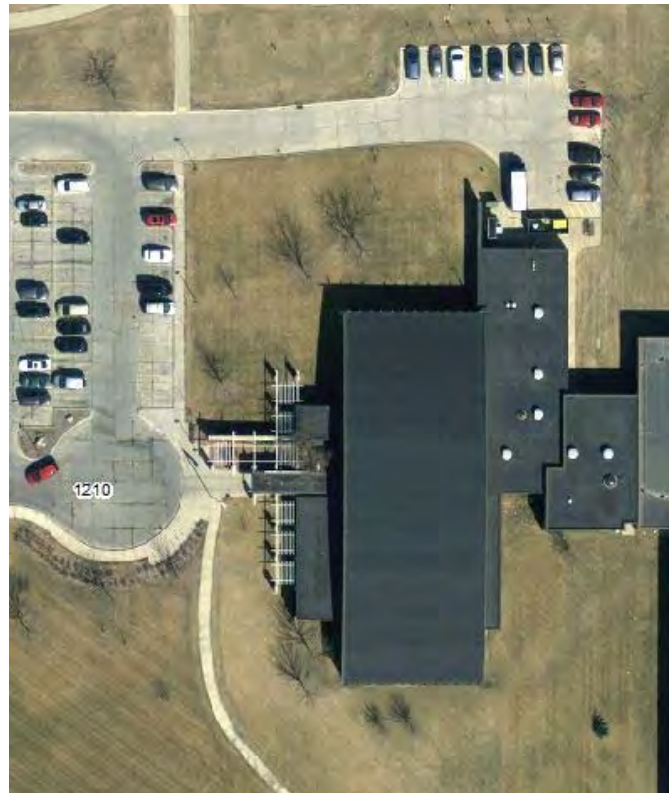
There is a small drop-curb access ramp that serves the four handicap stalls. This ramp has truncated dome panels and appears to be at the correct dimensions and grades, but this will need to be verified.

**Priority 2 Actions:** No further action is planned at this time, pending the remodeling of this building in the near future. Any infrastructure improvements would be feasibly impractical given the short term that they would be in place. If the planned remodeling of the building were to be delayed, then a more in-depth survey and scheduling of improvements would be recommended.

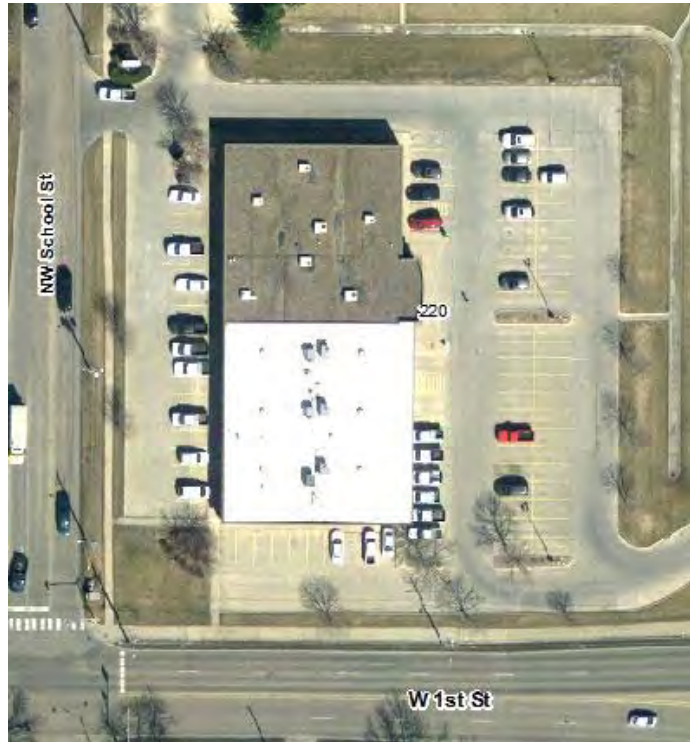
The parking lot contains 89 parking stalls, 2 of which are van-accessible handicap stalls. These stalls are located adjacent to the public entrance. They are of the correct dimensions and have the required handicap signs behind each stall. However, according to ADA requirements, this lot should have at least three handicap stalls.

The public entrance is entered from the parking lot by traversing a large semi-circular depressed curb ramp. This ramp does not have the required truncated dome panels. There are two additional depressed curb access ramps on the front of the building, and these are also missing the required truncated dome panels.

**Priority Actions:** A 3<sup>rd</sup> handicap stall will be installed as a Priority 1 improvement. This will be completed during the summer of 2016. No further action is planned at this time, pending the vacating of this building in the near future. If the planned abandonment of the building were to be delayed, then a more in-depth survey and scheduling of improvements would be recommended.

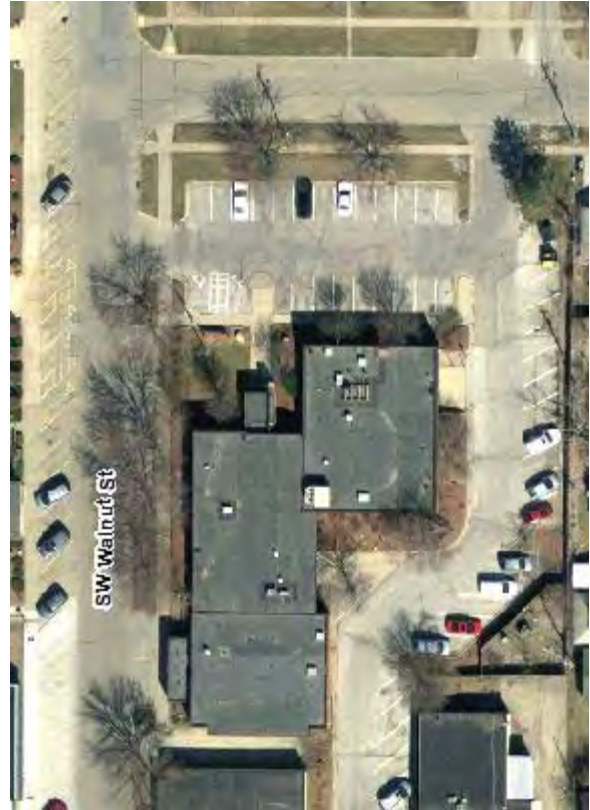
**Ankeny Art Center  
1520 SW Ordinance Road**

**Inventory:** This building is a former bank / credit union that was acquired by the City of Ankeny many years ago. It then functioned as the city public works department until it was leased to the Ankeny Art Center about 12 years ago. The asphalt parking lot was resurfaced in 2008. The east entrance into the building was reconstructed as well, including a new sidewalk and ramp into the building.

**Priority 1 Actions:** Install the 1 missing “van-accessible” plaque. This work is scheduled for the summer of 2016.

**Priority 2 Actions:** Public works needs to measure the dimensions and grades of the walkway and ramp areas to the parking lot to insure compliance.

**Priority 3 Actions:** The truncated dome panels that are missing from the ramp area in front of the main doors will need to be programmed for installation, along with an electric door opening device.

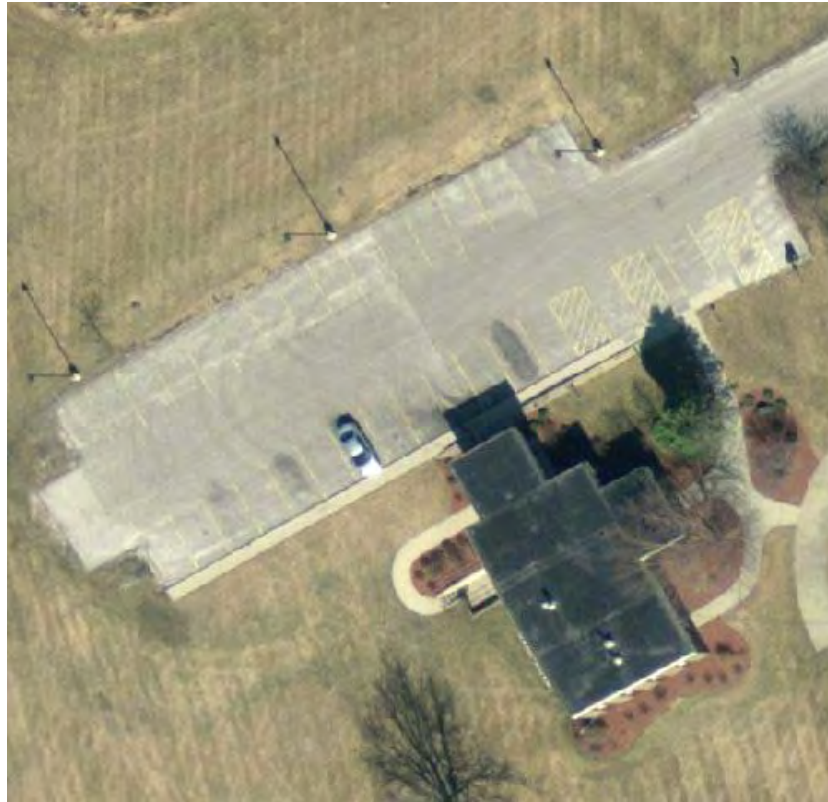
The building has two public accesses. The north access includes a set of steps between the parking lot and the building entrance. This is not handicap-accessible. The east entrance is at-grade with the parking lot, and includes a newer sidewalk between the parking lot and the building. There is an access ramp that includes truncated dome panels at the interface between the lot and the sidewalk. However, these panels are not configured correctly in relation to the adjacent handicap stalls.

The east entrance is marked as handicap-accessible, but the door does not have an electric opener.

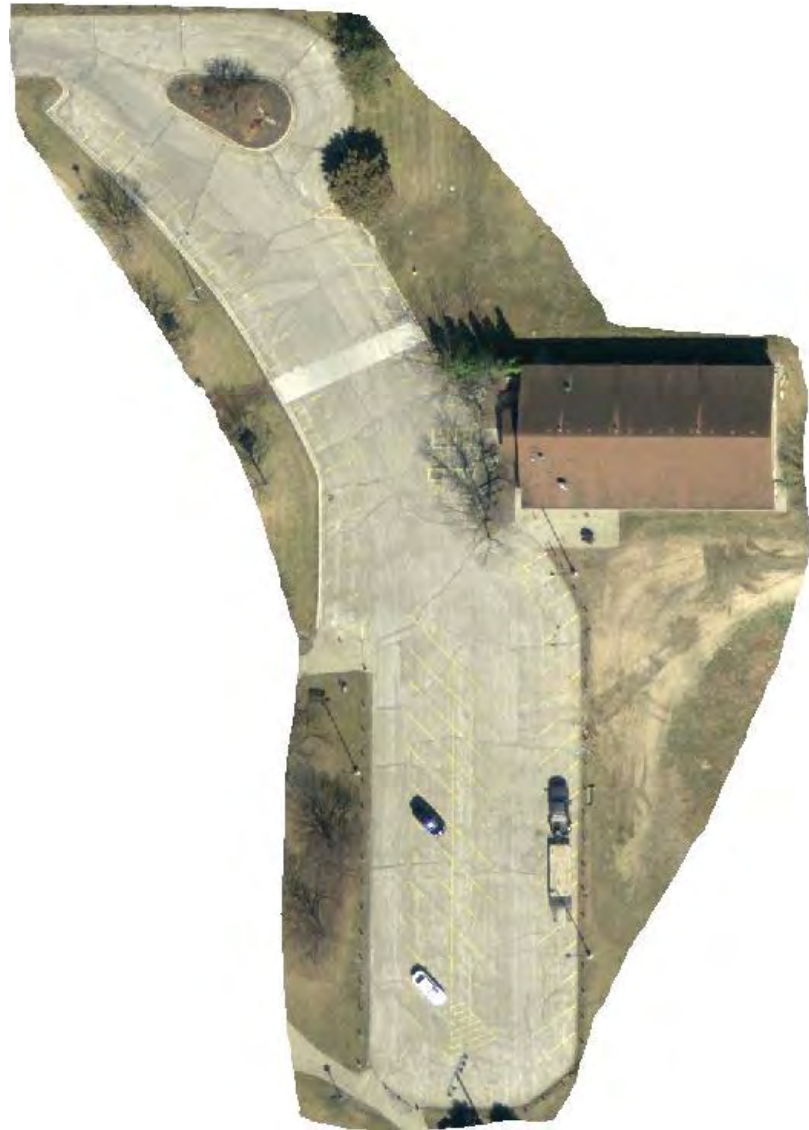
**Outdoor Education Center**  
**610 NE 36<sup>th</sup> Street**

**Inventory:** The Outdoor Education Center is an older wood-frame building that is used as a rental facility and classroom setting by the Ankeny Parks and Recreation Department. It is rented to small groups on a regular basis. The building is served by a small asphalt parking lot that contains 29 parking stalls.

**Priority 2 Actions:** Public works needs to measure the dimensions and grades of the drop-curb access ramp to insure compliance.

**Priority 3 Actions:** The public entrance door needs to be reconfigured to provide an electric opening mechanism.

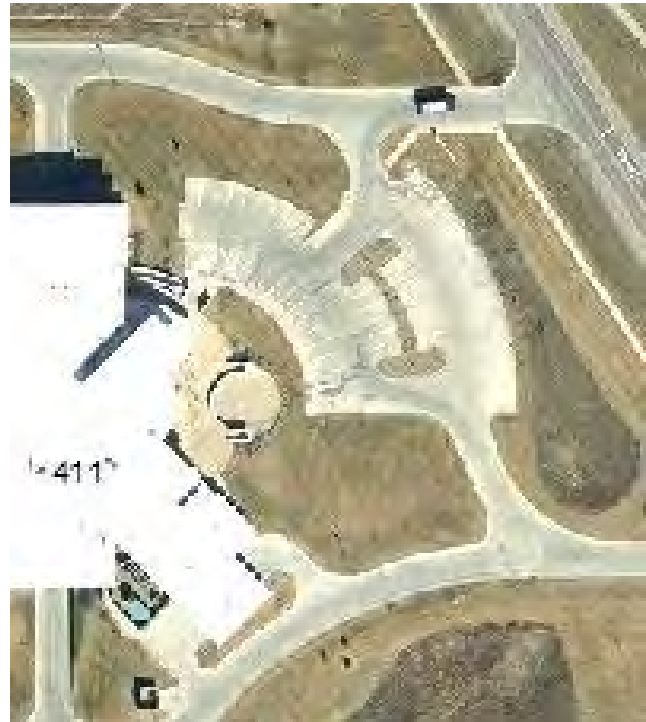
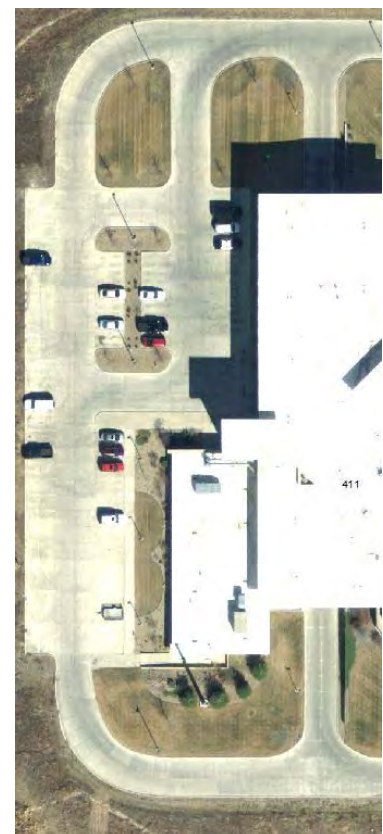
**Ankeny Fire Station #1**  
**120 NW Ash Drive**

**Inventory:** Fire Station No. 1 is located near the geographic center of Ankeny. It is our original station and still functions as our main (largest) fire station. The building includes a small museum and a training room, so the public utilizes this facility, though not on a regular basis. There are two parking lots serving the station. The east lot is adjacent to the public entrances into the station, and is used exclusively by the public. The west lot serves as the employee entrance, and is signed to prohibit public access.

**Priority 2 Actions:** The north drop-curb access ramp in the east lot needs to be reconstructed so that the required truncated dome panels are provided.

**Priority 3 Actions:** No actions needed at this time.

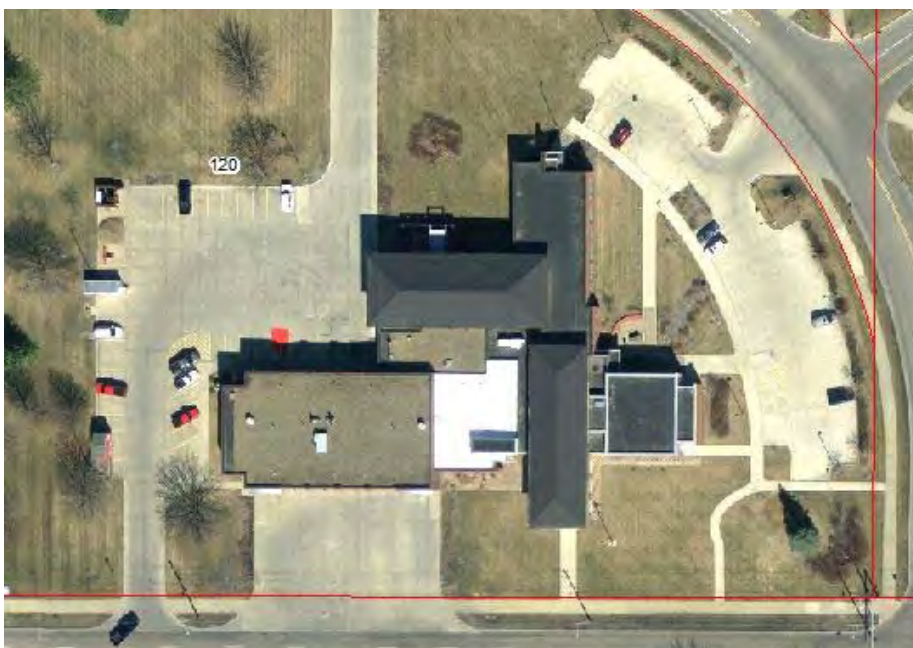
**Ankeny Fire Station #2**  
**665 SE Ordance Road**

**Inventory:** Fire Station No. 2 is located on the south side of Ankeny. This station was constructed in 2009. Unlike Fire Station No. 1, there is not public programming or public events held in this station. The layout is efficient and aimed at employee use only. There are 4 parking stalls in front of the station, adjacent to the main entrance. There are an additional 12 stalls for employees in the back of the station. The back lot serves as the employee entrance, and is signed to prohibit public access. Of the 4 front stalls, 1 is a van-accessible handicap stall, as required. The markings, dimensions and signing for this stall are current and meet the requirements.

**Priority 2 Actions:** No actions needed at this time.

**Priority 3 Actions:** Even though the drop-curb access ramp appears to be properly constructed, public works should measure the dimensions and grades of the ramp to insure compliance.
